MIDDLE DAM

NDI ID NO. PA-00256  
DER ID NO. 45-3

PHASE I INSPECTION REPORT  
NATIONAL DAM INSPECTION PROGRAM

JANUARY 1980

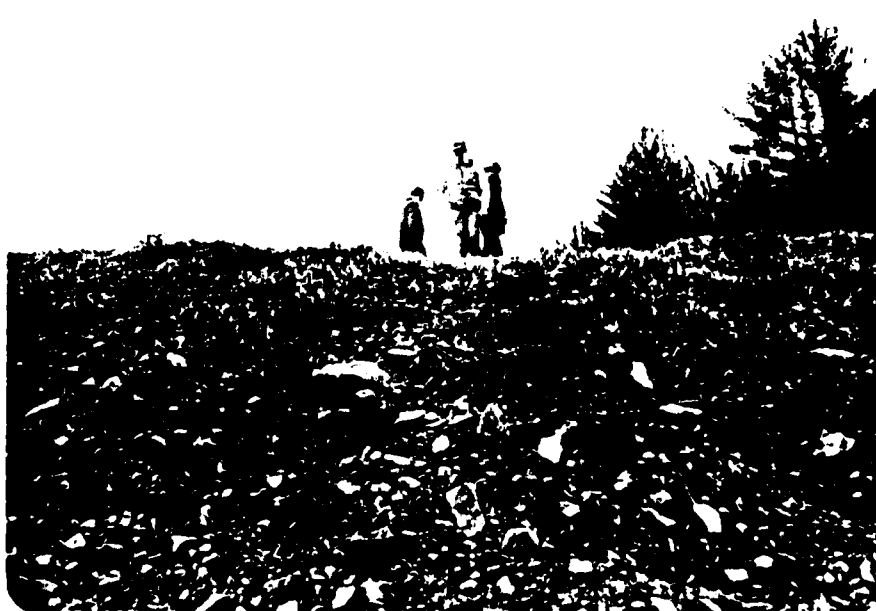
The downstream slope of the dam is covered with grass and is generally in good condition (Photographs B and C). One bare area about 500 square feet in size exists near the left abutment (Photograph D). The Owner stated that the area was disturbed in 1964 when the intake structure was constructed. No erosion has occurred at the bare area. Two burrowing animal holes are located on the downstream slope.

D. Downstream Slope Near Left Abutment.

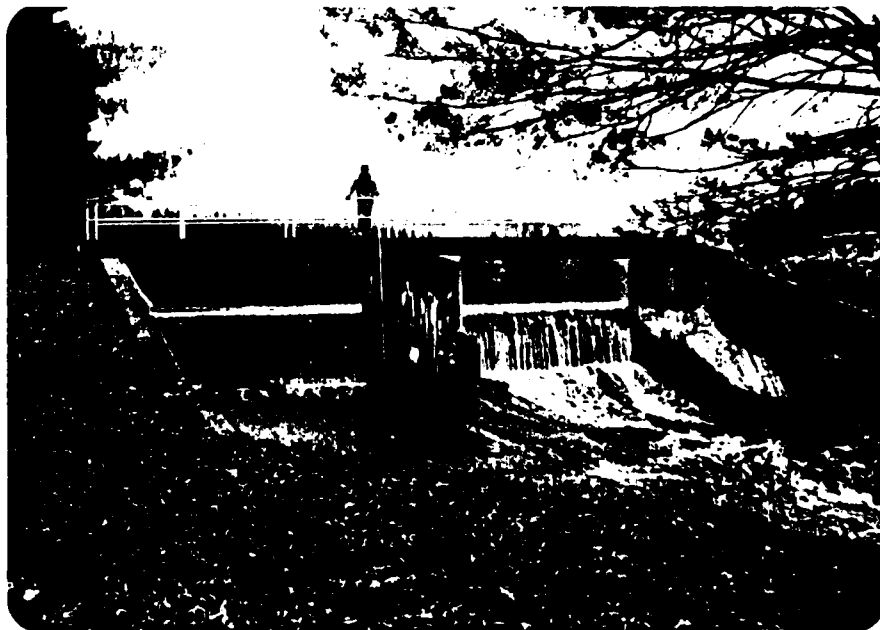
c. Appurtenant Structures. The concrete spillway weir is in good condition (Photograph F). Minor cracking and leaching are present on the spillway sidewalls and on the bridge pier. The right wall also had some spalling at the weir. The concrete apron at the toe of the weir on the left side of the spillway is damaged. Pieces of concrete about 3 inches thick are broken and displaced over about a 30-square foot area. It did not appear that the toe of the weir was undermined. Beyond the end of the concrete apron, the spillway outlet channel is in good condition (Photograph G). No erosion is present in the stone-lined channel. The underside of the spillway bridge is at Elevation 781.2, which is 0.1 foot above the design elevation of the top of the dam.

(3) Appurtenant Structures. The cracking, leaching, and spalling of the concrete spillway sidewalls are maintenance items and do not significantly affect the stability of the structures. The broken and displaced concrete in the apron was minor in terms of effect on stability at the time of the inspection. However, additional deterioration of concrete might lead to significant erosion of underlying material that would affect stability.

F. Spillway.

(2) Make repairs to the spillway apron. Perform additional investigations and studies to more accurately assess the stability of the spillway weir as well as the nature and extent of measures required to provide adequate factors of safety for all expected loading conditions. Take appropriate action as required.

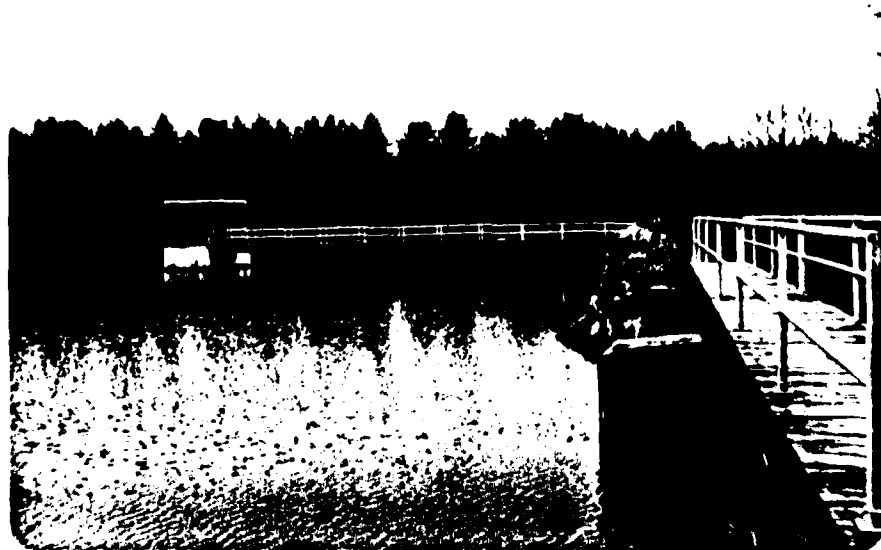
The intake structure located in the reservoir is in good condition (Photograph H). The Superintendent of Public Utilities stated that the three slide gates in the intake structure are all in good working order. Since there are no outlets at the dam, it was not requested that the gates be operated for this inspection. An examination was made of the valve chamber located along the downstream side of the corewall. Standing water about 12 inches deep and mud were present in the tunnel (Photograph I) and valve chamber. The two gate valves were nearly submerged. The source of the water could not be determined. The exposed portion of the corewall in the valve chamber is in good condition. It was damp at several locations, but there were no leaks.

H. Intake Structure.
